Case Studies Assessment Report

SHC Task 59 | EBC Annex 76 | Report D.A2

IEA SHC Task 59 | EBC Annex 76: Deep renovation of historic buildings towards lowest possible energy demand and CO₂ emission (NZEB)

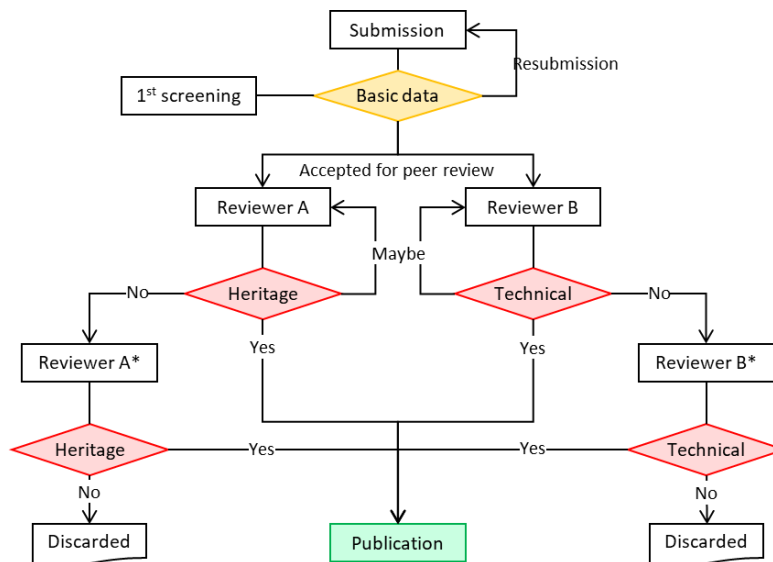
Figure 1: Review process in SHC Task 59

After checking the completeness of the information provided, the best-practice is assigned to at least two members with different expertise: Heritage or Technical. If a case study is rejected by one of the reviewers, this is submitted to an alternative reviewer for a second opinion. A second rejection will mean that the project should not be included in the database.

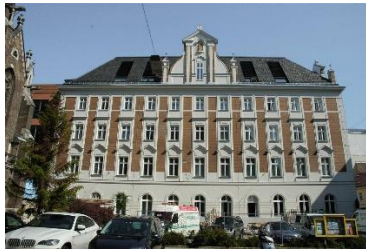
A multi-purpose used convent building in the heart of Vienna has been refurbished with particular attention to monument preservation and to a new solution for renovating Viennese-type box windows. The goal was to present a sustainable system solution with the energetic refurbishment of the existing building and the highly efficient loft conversion according to the requirements of the monument protection.

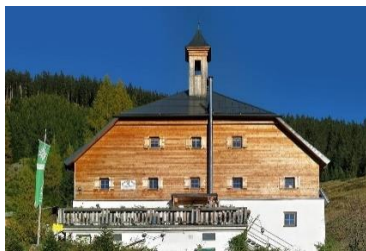
Exemplary sustainable renovation of a historic mountain hut at 1,432 meters above sea level in Aurach near Kitzbühel. The renovation resulted in a significant increase in the levels of comfort in a mountain hut exposed to severe weather conditions. The building is used all year round after renovation.

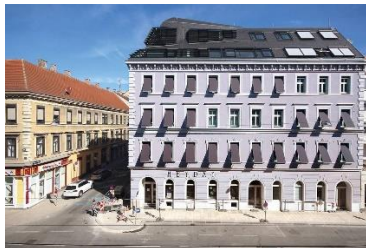
Modernization of a Gründerzeit building with the use of an aerogel insulating plaster after it was demolished by an gas explosion. In addition to the restored façade, the exterior of the new attic storey is initially noticeable. The building received two major awards: the 1st prize of the 33rd Vienna Urban Renewal Prize by the National Guild Construction Vienna, and the State Prize for Architecture and Sustainability 2019 by the Federal Ministry for Sustainability and Tourism.

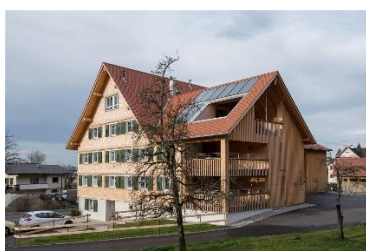
The owner managed to renovate the building in a way, which kept the outer appearance. The hole faced and situation of the roof were kept. The main house did not change much while the extension changes in function and design to a more modern part of the building. All windows were exchanged by wooden windows, which all have good thermal values. The living area changed from a 4-flat house of 370m² for in average 5 person to a 7-flat house for 12 residents. The heating requirement before renovation was 142 kWh/m²a and could be reduced to a quarter of this. A thermal solar system now supports the former heating system of gas.

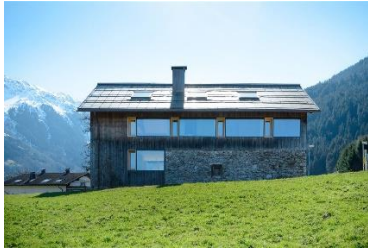
House Breuer Tschagguns, AT	Building Period: 1900 - 1944 Renovation: 2015	Use: Residential (rural) Protection level: not listed	Contact: Energieinstitut Vorarlberg
--	--	--	--

The associated farmhouse was demolished at the beginning of the 1970s. The aim was to convert the farm building into a high-quality residential building. In the process, the outer shell was supplemented by a few openings, which makes the new use of the building readable. The work on the original construction was carried out using old techniques wherever possible. Thus, the plugged connections are again in this form. The outer wooden facade was preserved entirely.

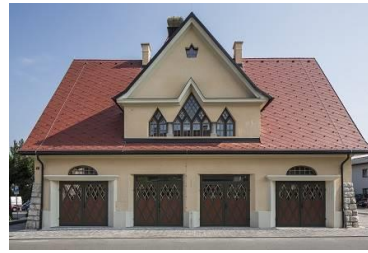
Music School Velden Velden, AT	Building Period: 1900 - 1944 Renovation: 2015	Use: Educational/Research Protection level: listed	Contact: e7 energy innovation & engineering
---	--	---	--

Restoration of a former fire station and transformation into a music school including a comprehensive thermal-energetic renovation. The renovation of the listed building was carried out within the framework of the demonstration programme "Mustersanierung".

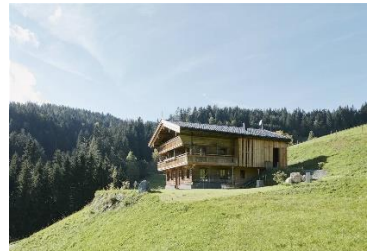
Hof Neuhäusl Tirol, AT	Building Period: 1700 - 1800 Renovation: 2017	Use: Residential (rural) Protection level: not listed	Contact: University of Innsbruck
-----------------------------------	--	--	-------------------------------------

The 300-year-old "Hof Neuhäusl" is a prime example of the combination of old building stock and energy efficiency. While retaining its historical appearance, the building was refurbished completely in 2017. The preservation of the façade required the implementation of consistent interior insulation. Inside, the rooms were restructured in order to meet the highest, modern living standards. The revitalisation of the courtyard was awarded with the "Tiroler Sanierungspreis" in 2018.

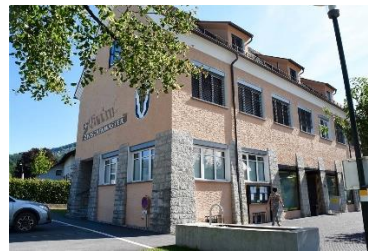
Community Hall Zwischenwasser, AT	Building Period: 1900 - 1944 Renovation: 2015	Use: Community Hall Protection level: not listed	Contact: Energieinstitut Vorarlberg
--	--	---	--

The comprehensive modernisation of the municipal office has now also been completed to a high standard. While the ground floor was on the raised ground floor before the conversion, large parts of this level have now been lowered to street level and glazed and thus converted into a barrier-free and transparent citizens' office. The renovation relies on night cooling and cross-ventilation. The reduction of the heating energy demand is achieved, among other things, by a wall system of interior insulation with clay plaster and at the same time makes it possible to leave the façade unchanged.

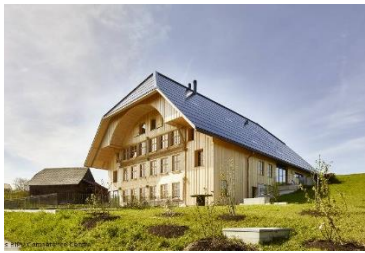
Glaserhaus Affoltern, CH	Building Period: 1700 - 1800 Renovation: 2015	Use: Residential (rural) Protection level: listed	Contact: SUPSI
-------------------------------------	--	--	-------------------

This restoration is connected with the aim of preserving the overall appearance of the building, repairing the roof, facades and surroundings and carefully restoring the prestigious south facade. From a technical point of view, the building is solidly stabilised and energetically brought up to the latest standards. The project was developed with the involvement of the cantonal monument preservation authorities. Several meetings and inspections took place, on the basis of which the project was further developed in accordance with the requirements of the preservation of historical monuments.

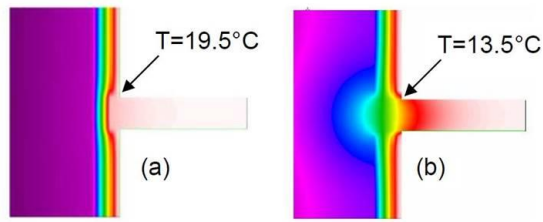
Figure 2: 2-dimensional simulation of partition wall abutting outside wall with THERM a) thermal division b) no thermal division

The problem of thermal bridges was also considered in detail for some buildings. In case of refurbishments with external insulation, remaining thermal bridges mostly only caused higher heat losses. In case of internal insulation, they can quickly lead to moisture damage. Wherever possible, at the "Ansitz Kofler" the internal wall was cut and insulation placed vertically against the wall. Where new partition walls were built up, interspaces to the external wall were left in order to place insulation, OSB-boarding and vapor retarder behind. Thus, the energy losses as well as possible moisture damage, caused by the thermal bridge of inner walls, were avoided.

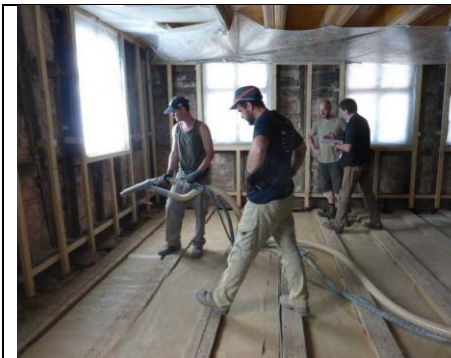
Figure 3: timber framed house in Alsace, sprayed hemp concrete

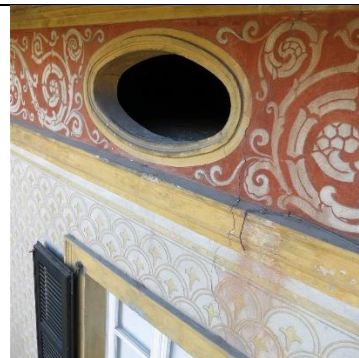
Figure 4: Villa Castelli, historical plaster and painting

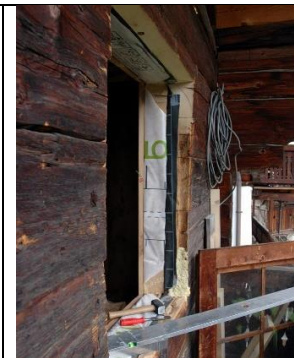
Figure 5: Aussergrubhof, internal hemp fibre insulation

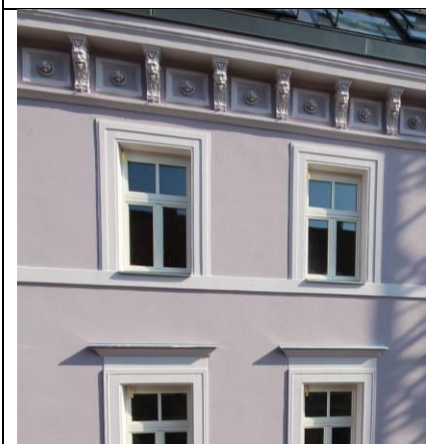
Figure 6: Mariahilferstraße 182, aerogel facade

External insulation was mostly used for unlisted buildings and for building components that were not subject to any requirements by the heritage agency. But even there, the preservation of proportions was considered. At the Mariahilferstraße 182, the outer walls were moved inwards to make space for a 20 cm thick hemp insulation.

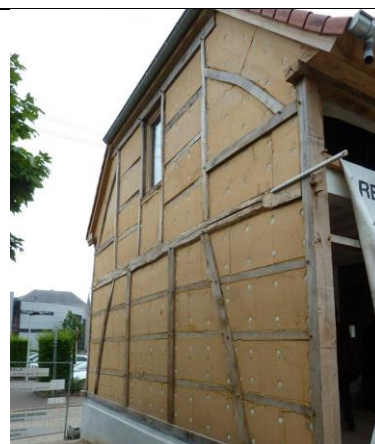
Figure 7: half-timbered house in Alkjen, wood fibre board with clay plaster

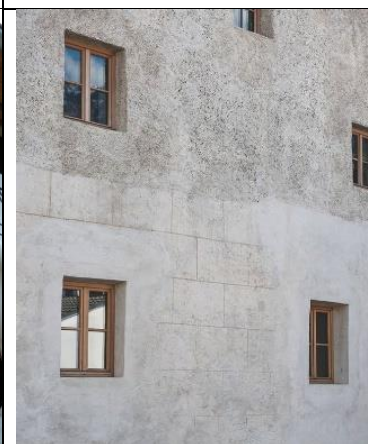
Figure 8: Ruckzaunerhof, historic plaster from the 16th century

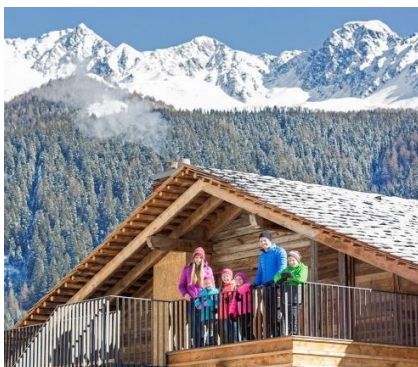
Figure 9: Rainhof, roof with long shingles and insulation between rafters

In order to meet the visual requirements of the monument protection, insulation between rafters is a good solution. The proportions of the building remain unchanged and the roof covering can be retained. Also, with other roof insulation solutions the original roof covering can be reused or reproduced. For example, the "Rainhof" (figure 9) was covered with long shingles, the "Klostergebäude Kaiserstraße" (figure 14) and the "Hollywood Park Lodge" (figure 12) were covered with the original slate tiles. In the case of the "Klitgarden", the historic thatched roof was completely preserved and thermally improved with additional insulation between the rafters.

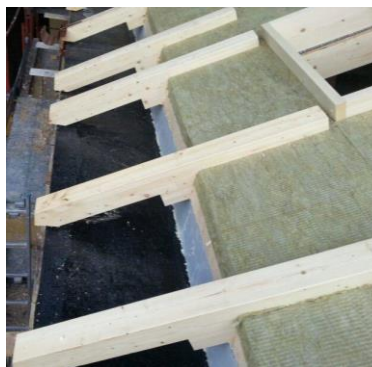
Figure 10: Villa Castelli, new pitched roof

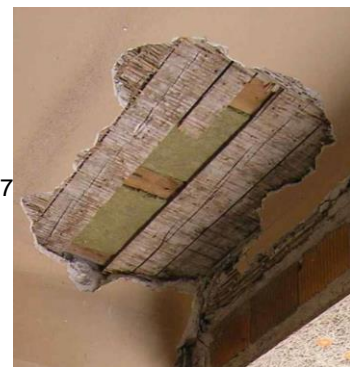
Figure 11: Ansitz Kofler, bottom view of the insulation between the rafters

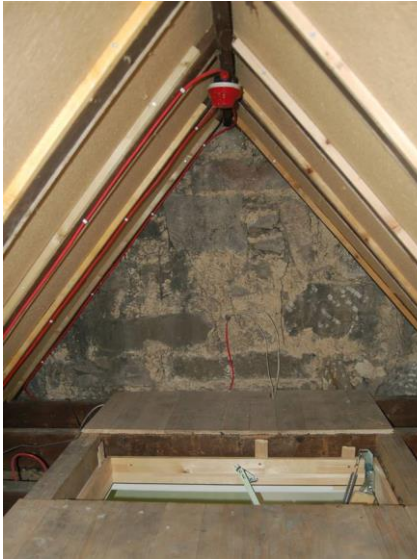
Figure 12: Hollyrood Park Lodge, pitched roof with wood fibre

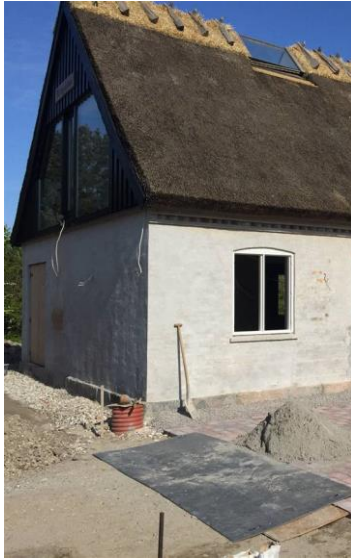
Figure 13: Klitgaarden, original thatched roof with internal insulation between the rafters

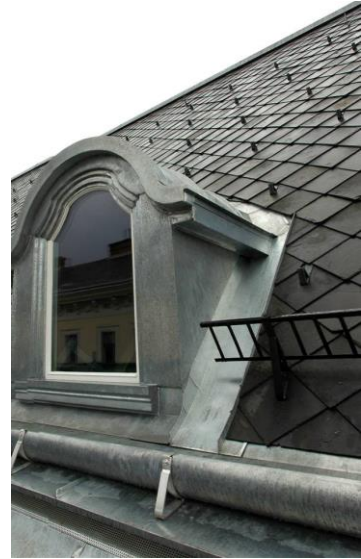
Figure 14: Klostergebäude Kaiserstraße, roofing with original slate tiles

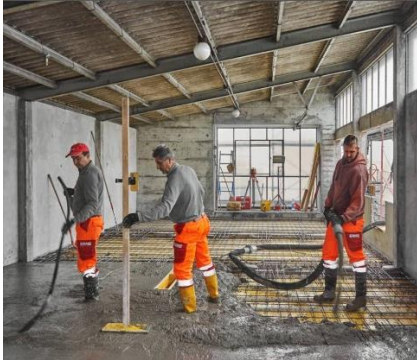
Figure 15: Solar Silo, old beam structure

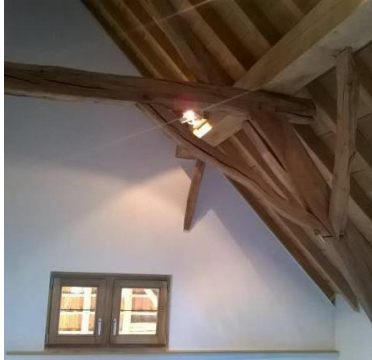
Figure 16: Half timberframed house in Alken, old roof truss with some new elements

In some cases, parts of the roof truss are damaged so badly that renovation is almost impossible. In 22 cases the roof truss was therefore completely renewed. As some examples show, this is also possible for listed buildings while retaining the roof shape and the materials used.

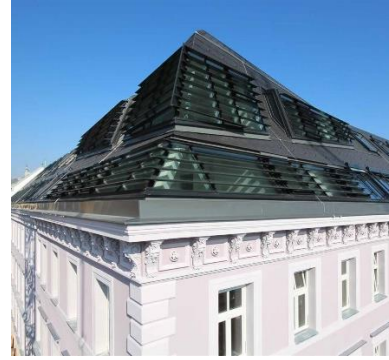
Figure 17: Mariahilferstraße 182, modern roof solution

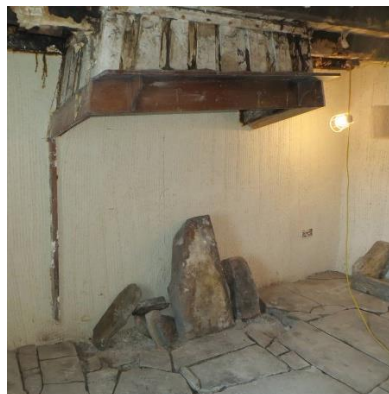
Figure 19: Downie's Cottage, original flagstone floor

For example, at "Downie's Cottage" the original flagstone floor was reinstalled (figure 19). In the case of the "timber framed house in Alsace" the existing terracotta tiles were used again. Wooden floors can also be reused, as the example of "Hollyrood Park Lodge" shows. In figure 23 you can see the reinstallation of the quarry stones at the "Ansitz Mairhof".

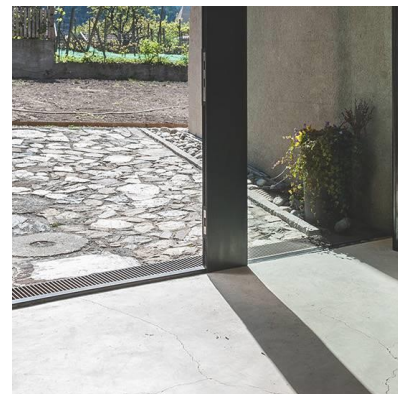
Figure 20: Ruckzaunerhof, new floor construction

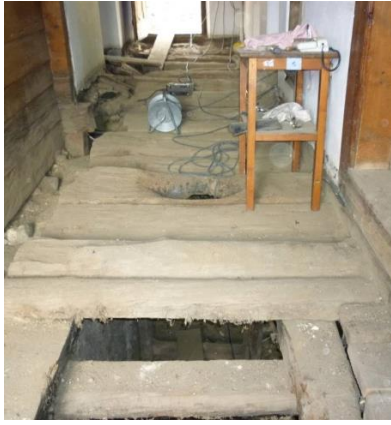
Figure 21: Aussergrubhof, old wooden floor joists

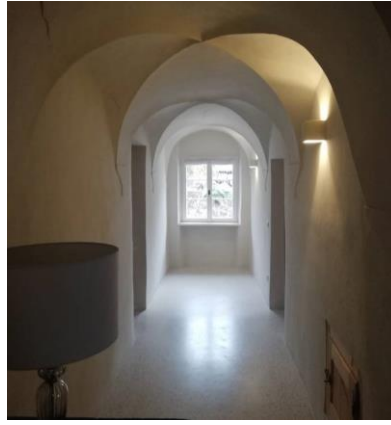
Figure 22: Oberbergerhof, imitated terrazzo floor

Another possibility is the imitation of existing floors. In the case of the "Oberbergerhof" the existing terrazzo floor was reproduced (figure 22).

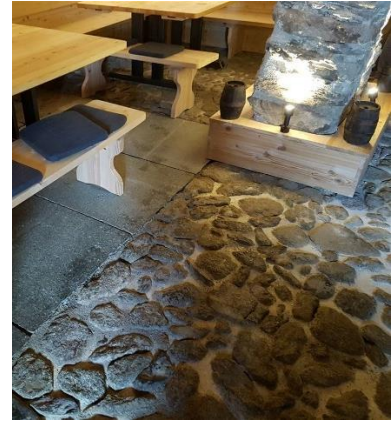
Figure 23: Ansitz Mairhof, historical floor made of quarry stones

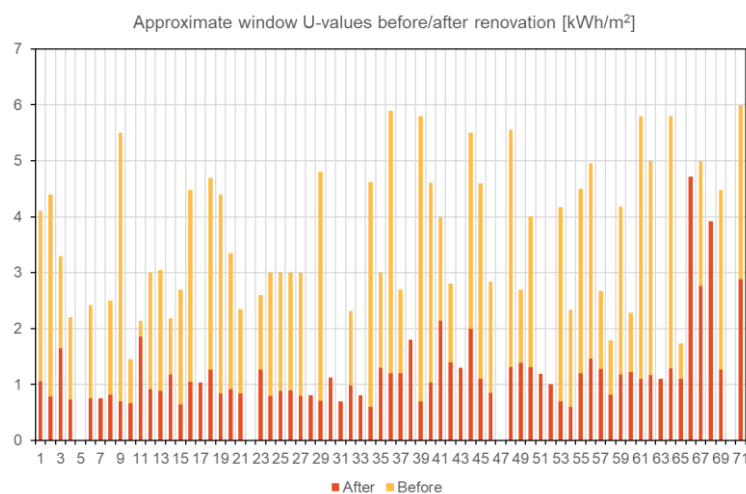
Figure 24 shows a comparison of the approximate total window U-values before and after the renovation. From the figure it is quite clear that in most cases, the renovation has increased the energy efficiency of the windows significantly.

Figure 25: Window U-values before and after renovation.

The main reason for the improvement in the rest of the cases are due to the fact that single-layer glazing is replaced by either double- or triple-layer glazing, however, some cases also see slight improvements in window frames, reveals etc.

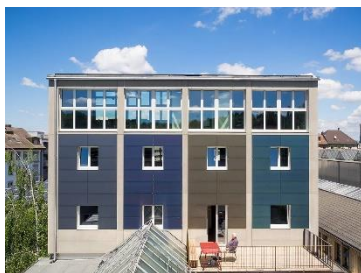
Figure 26: **Solar silo**. New windows added to the façade.

Adding new windows is a way to achieve a high level of energy efficiency and improving daylighting in the buildings, however, this solution will only be relevant in buildings or parts of buildings that are not protected and where there is a high degree of freedom for the architect. In the **Solar Silo** it was necessary to transform the building from silo to offices and hence add windows; in **Osramhuset** roof windows did not change the protected façade and improved daylighting levels significantly and in **Doragno Castle** there were no restrictions which allowed for adding a modern touch to the building with panoramic windows.

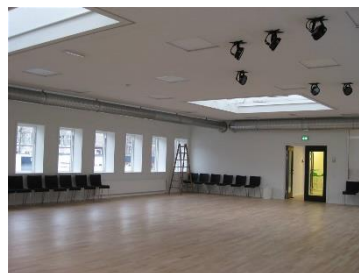
Figure 27: **Osramhuset**. New roof windows increased daylighting levels.

In **Osramhuset** new roof windows were added. Only the building's façade was protected and therefore adding roof windows was a way to significantly increase daylighting levels in the building while also providing an opportunity for natural ventilation. The roof windows were double-layer wood/aluminium windows with argon and a U-value of 1.80 W/m²K.

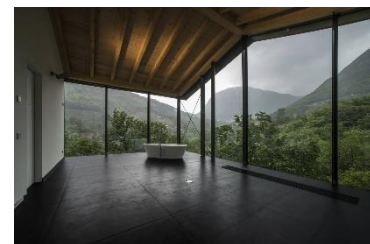
Figure 28: **Doragno Castle**. New large windows to improve daylighting.

In **Doragno Castle** new large windows and glass facades were added. The original stone walls are highlighted by the large windows completing the volume of the existing building. The windows have double- or triple-layer glass and aluminium frame and the U-value ranges from 1.0 – 1.2 W/m²K.

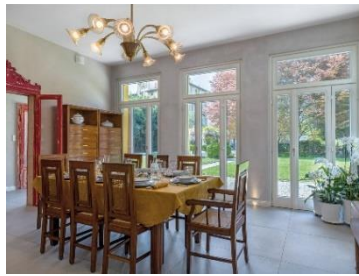
Figure 29: **Villa Castelli**. Old windows replaced by similar new ones.

For **Villa Castelli**, the original windows were not of heritage value and therefore they were replaced with new more energy-efficient windows. The new windows were handcrafted by a carpenter in wood-aluminium and the only requirement of the heritage authority was to maintain the original layout of the windows (number and thickness of sashes etc.).

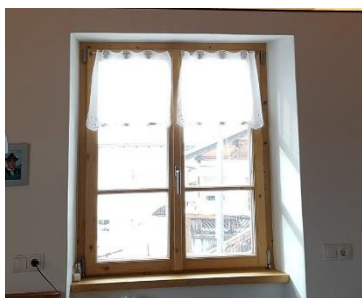
Figure 30: **Mairhof**. All windows were replaced.

In **Mairhof**, all windows and doors, including existing PVC windows with double-glazing, were replaced by wooden windows with triple glazing.

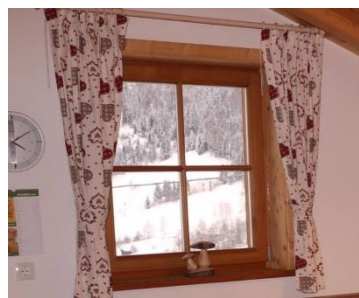
Figure 31: **Obergasserhof**. Single-leaf and double-glazed new windows.

For **Obergasserhof**, as part of the energy upgrade, the old windows from the 1970s were replaced with new, single-leaf and double-glazed lattice windows.

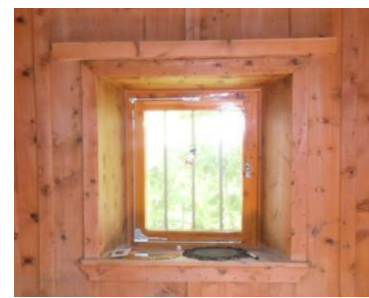
Figure 32: **Platzbonhof**. Triple-glazed windows improved energy efficiency.

In **Platzbonhof**, the existing windows were replaced by new triple-glazed wooden windows. The windows have been completely replaced, only the lintel has remained.

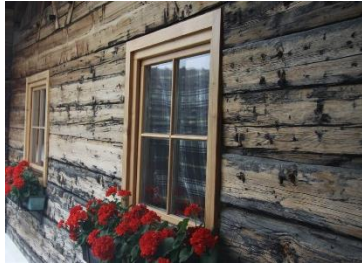
Figure 33: **Aussergrubhof**. Larch wood double-glazed windows.

Aussergrubhof had existing windows from the 1970s. These windows were replaced by larch wood windows with double-glazing.

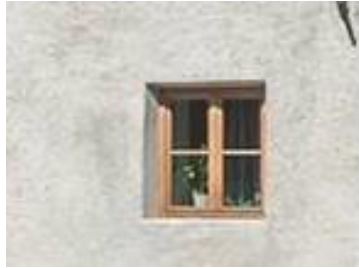
Figure 34: **Ruckenzaunerhof**. New windows selected in close cooperation with monument office.

In **Ruckenzaunerhof**, indoor lighting levels was a problem due to the small-format windows. To ensure that enough light enters the house, clear views were an important point during the renovation. This also increased the solar energy gains. All existing windows were replaced with new double-glazed windows in order to meet today's energy standards. The selection of new windows was carried out in close cooperation with the monument office. The original materiality of the wooden windows, as well as the typical rungs should definitely be restored.

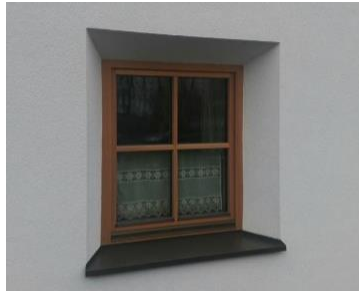
Figure 37: **Bauernhof Trins.** Windows is local style.

In **Bauernhof Trins**, the windows were completely replaced. The new wooden windows in the local style were pre-installed in the custom-made wooden wall elements. The optimized position of the window frames in the insulation layer increases thermal comfort and reduces the risk of condensation through minimized thermal bridges.

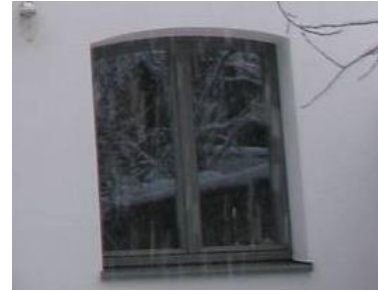
Figure 38: **Maison Rubens.** New oak wood windows.

For **Maison Rubens**, the windows were replaced with new ones of oak wood. The new windows are identical to the original and has the original shape. Most of the windows have been replaced and only the ones on the front façade at first floor were kept because they already had double-glazing.

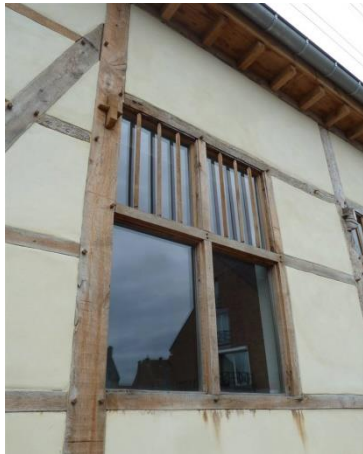
Figure 39: **Half-timbered house in Alken.** Handcrafted windows.

In the **Half-timberframed house in Alken**, the windows were in a very bad state. There were windows (remains) from the 17th, 19th and even 20th century. In some places the windows were also missing. The remaining wooden joinery in the half-timbered house has been completely replaced by typologically appropriate new joinery. The new windows have double-glazing and in order to accommodate this, the profile thickness has been adjusted slightly.

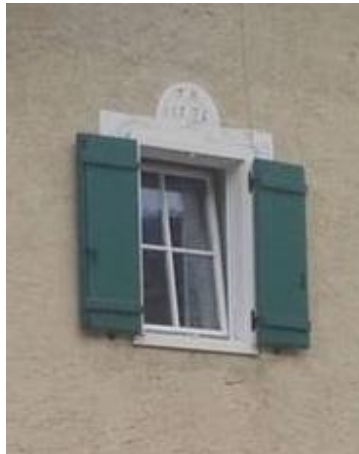
Figure 40: **Oberbergerhof.** Thin frame with a historic appearance.

In **Oberbergerhof**, most of the windows have been replaced. The bifora windows (mullioned windows with two lights) from the late renaissance were preserved in the middle room on the second floor. The windows in the apartment were renewed, while four new windows were added to the roof on the top floor. In the knight's hall, the old, historical windows have been preserved and not changed. When replacing the windows, special care was taken to ensure that the view of the courtyard was not changed. Therefore, it was only possible to provide the very thin frames, which appear historic in shape, with double-layer glazing, i.e. triple-layer glazing was not an option.

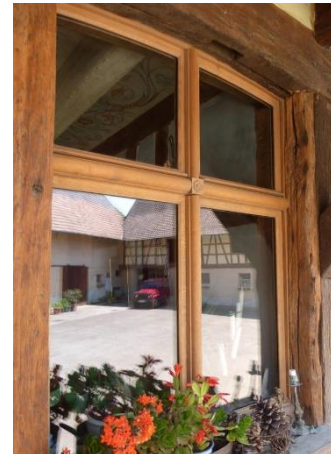
Figure 41: **Timber-framed house in Alsace.** New double-glazed solution.

In **Timber-framed house in Alsace** all the original single-glazed wooden windows were replaced by double-glazed ones dedicated especially to heritage buildings. Thanks to pictures from the beginning of the 20th century, it was possible to restore the windows as they were originally. The windows were made to measure by a local joiner. Heritage authorities had to be convinced that a double-glazed solution would fit the original design of the windows and therefore the owner and the joiner had to produce a prototype of the window which that finally convinced the heritage board.

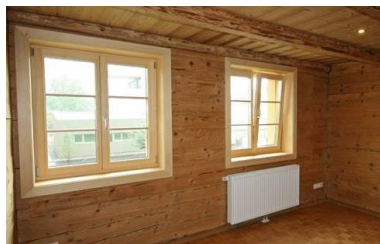
Figure 43: **Baur Residence, Lustenau.** Windows moved back to original place

In **Baur Residence, Lustenau**, the windows from the 1960s were replaced and building sins were eradicated by partially moving the windows back to their original place. This not only restored the character of the Rhinevalley house, but also brought more daylight into the building. The existing windows on the upper floors were replaced by windows in passive house quality.

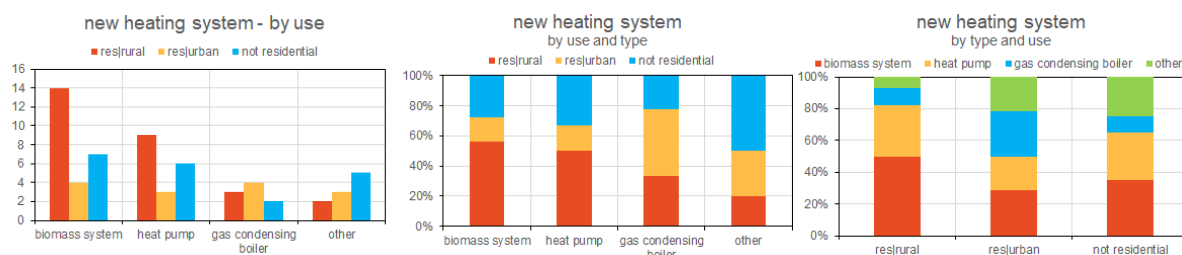
The tendency towards biomass and heat pump systems is especially pronounced in rural residential buildings, as Figure 51 shows. Gas condensing boilers have been chosen mainly in urban residential buildings. Other systems which include the district heating systems (7 out of 10) are most often use in not residential buildings.

Figure 51: New heating system by use and system type

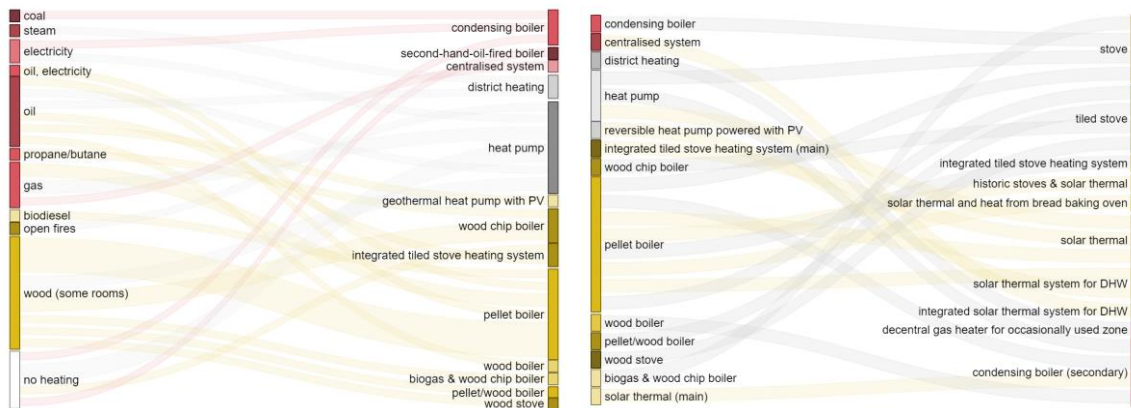
In a bit more than half of the cases (39 out of 69) information was also given on the old system which was exchanged (including the 6 buildings with explicitly say, that the building had not been heated). The **change of system** has been depicted in the left sankey diagram with redish colours for not renewable and yellowish colours for renewable energy systems (district heating and heat pump remaining grey, as they can be both): there is clearly a **shift** from not renewable to **renewable** systems visible, even if the completely new systems were in one third of the new cases not renewable ones.

Figure 52: Change of heating system (for the 39 cases where this information is available)

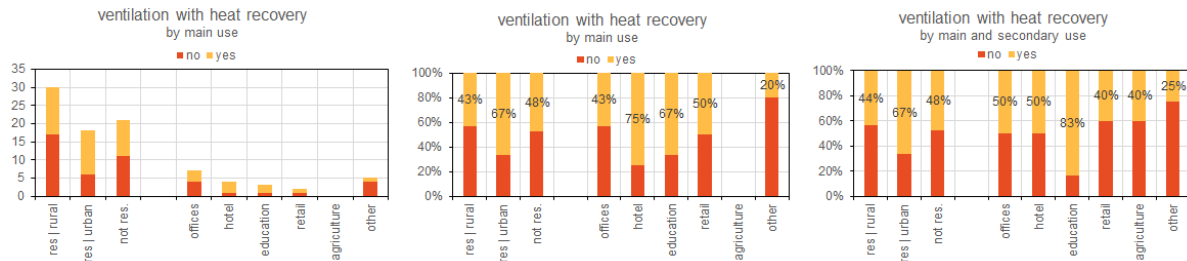
35 buildings with MVHR correspond to slightly more than half of all the documented good practice buildings. The fact that looking specifically at listed buildings, 47% have been equipped with a ventilation with heat recovery, induces, that it might be slightly but not considerably more difficult to integrate a ventilation system in a listed building. The analysis looking at whether buildings are situated in conservation areas or are both – listed and in a conservation area - shows the same trend.

Figure 54: Ventilation with heat recovery by main use in absolute numbers (left) and share (mid) as well as by both considering main and secondary use (right)

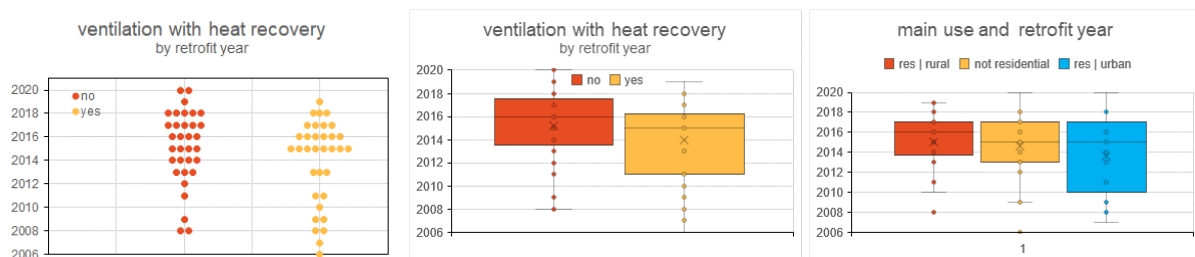
Figure 55: Year of retrofit – by ventilation with heat recovery (left) and main use (right)

The hypothesis, that recent retrofits might more often include MVHR since experience on how to implement it is rising is not supported by the collected data: the whisker plot of retrofits with and without MVHR actually shows that those with MVHR are on average “older”. This could, however, also be due to the fact that there is dominance of rural residential retrofits in the documented recent cases, which as has been shown above are less likely to be equipped with MVHR.

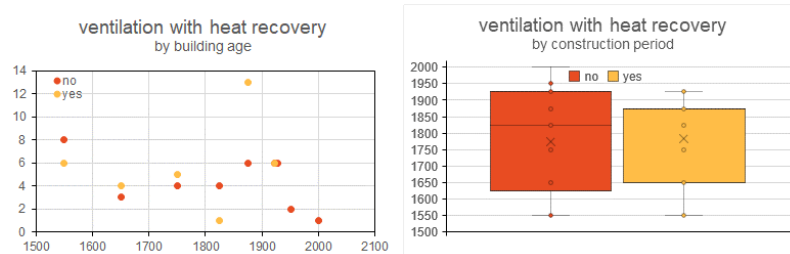
Figure 56: Differences by construction period

There is also no evidence in the data, that the implementation of a MVHR is more difficult in older buildings. The whisker plot (see Figure 56 on the right) shows very similar values for the “average age” of buildings with and

without MVHR, the range just being wider for those without. This can also be observed in the left plot: both for the newest and the oldest buildings slightly less buildings were retrofitted with MVHR. A particularly high share of retrofits with MVHR can be observed for buildings dating 1850 – 1900.

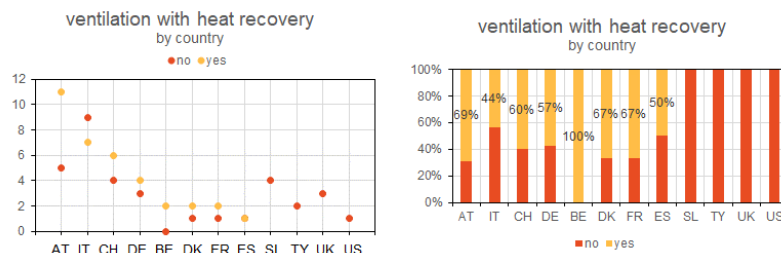
Figure 57: Differences by country

Investigating whether there can be observed differences from country to country, shows on the one hand side, that most best practice cases with MVHR have been reported for Austria, followed by Italy and Switzerland. It is worth noticing however, that all best practice from Belgium have a MVHR, followed by Austria, Denmark and France with two thirds. On the other hand, none of the cases documented for Slovenia, Turkey, the United Kingdom and the states was equipped with MVHR.

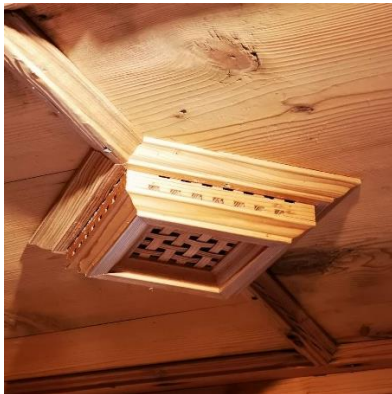
Figure 58: farm house Trins, ventilation ducts

With regard to the protection of historical monuments, the ventilation must be as invisible as possible. Active overflow solutions and cascade ventilation considerably reduce the amount of pipework. For these old buildings you also have to be a little inventive in how to hide the air supply and exhaust air pipes. Old chimney flues and existing shafts can be used. For the "Farm house Trins" the air vents were hidden in the suspended wooden ceiling and integrated as unobtrusively as possible (figure 56). In the case of the timber-framed house in Alsace, the pipes were concealed and plastered between the joists. The owner did not want to see the exhaust and air intake vents on the roof, so he hid them behind shutters and near an exterior staircase. Attics can be used specifically for the ventilation units, as the example in figure 58 shows.

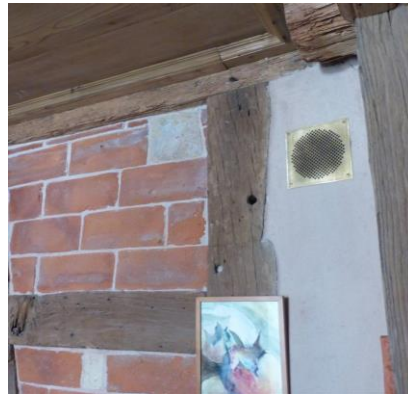
Figure 59: Timber-framed house in Alsace, supply air invisible between joists

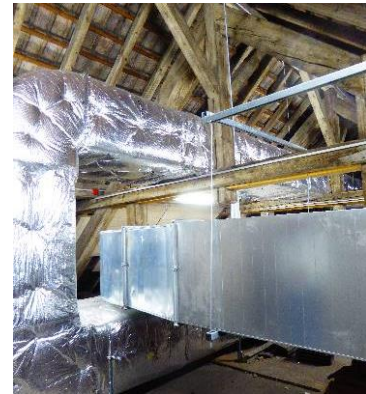
Figure 60: Elementary School "Cour de Lorraine", dual flow units in the attic

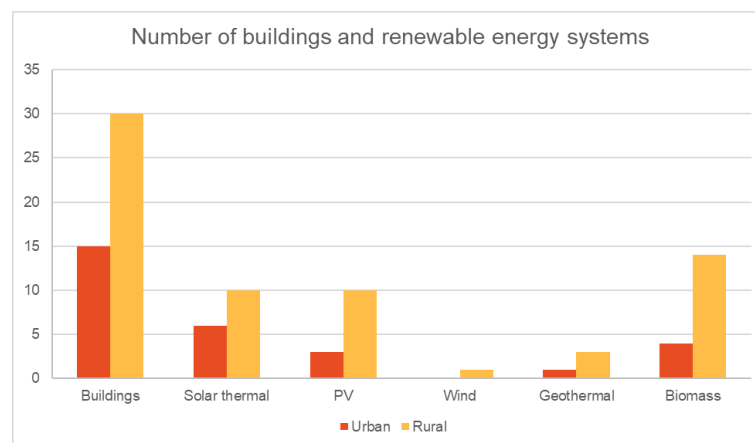
Figure 61: Urban and rural buildings and distribution of renewable energy systems.

Figure 59 shows the total number of buildings and the number of buildings in each category that utilizes the different types of renewable energy sources. If we compare the setting of the buildings (15 urban / 30 rural) and the use of renewable energy sources, it is clear that in particular photovoltaics and biomass is more often favoured in a rural setting.

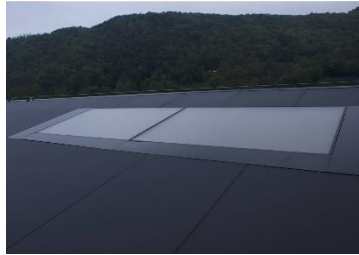
Figure 62: Integration of solar thermal panels in the roof of **Doragno Castle**.

In **Doragno Castle** solar thermal collectors were integrated in the south-east roof pitch for the production of domestic hot water and heating. The selected roofing materials allowed for the integration of solar systems making a uniform surface, considering the aesthetic characteristics of the solar thermal panels and their geometry and position in the roof, i.e. the solar thermal modules are coplanar to the roof minimizing their visibility from the surrounding environment.

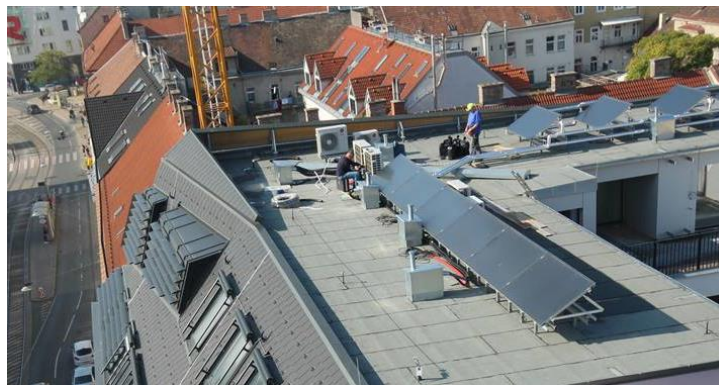
Figure 63: **Mariahilferstrasse**. Solar thermal installation on the roof.

In **Mariahilferstrasse** a 30 m² solar thermal plant was installed on the roof. The plant supports the production of domestic hot water for the building. The new solar thermal system did not interfere with the conservation compatibility.

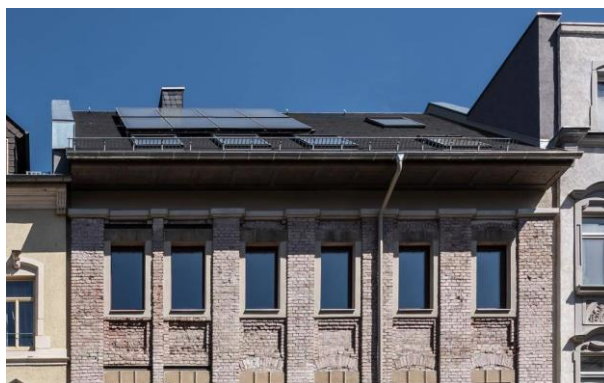
Figure 64: **Casa Rossa Chemnitz**. Coloured Solar collector colour adapted to roof skin. (Source: Bodensteiner Fest Architekten BDA).

In **Casa Rossa Chemnitz** the colour of the solar collectors was adapted to the roof skin. A rooftop system was chosen to enable simple reversibility of the technical component as soon as there are fully compatible components in terms of design, which is often a requirement for monument protection. Together with the roof windows, they represent a negligible disturbance of the roof landscape.

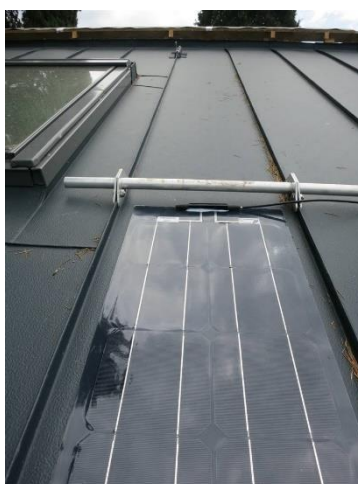
Figure 65: **Villa Castelli**. PV-panels integrated in the roof.

Villa Castelli, is heated by a heat pump and it was a requirement that the remaining energy demand should be covered locally and in a renewable way. Therefore, a PV-system, integrated in the roofing and not visible from outside, was installed. Before the heritage authorities approved the PV system, several prototypes were developed for a roof-integrated and preferably invisible installation. The heritage authorities opted for the double-curved aluminium sheet covering of the roof with integrated mono-crystalline PV modules. The nominal power of the system is approx. 11 kWp. As a curiosity, it can be mentioned that a sailboat outfitter supplied the extra-thin PV modules.

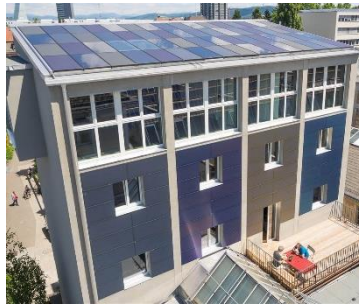
Figure 66: **Solar Silo**. Coloured customized photovoltaic modules creating a particular visual design.

In **Solar Silo**, there were no restrictions on the roof and façade of the building and therefore innovative coloured customized photovoltaic modules were used, creating a particular visual design to the building. As the „Gundeldinger Feld“-area as a whole is under heritage protection, the remodelled building was required to match the style and colour scheme of the site. The cladding (facade) consists of coloured frameless photovoltaic modules and fibre cement panels. The entire roof is covered with coloured and conventional PV modules. The modules are ventilated and serve as the water-bearing stratum. The total collector area is 159 m² and the system has a nominal power of 24 kWp.

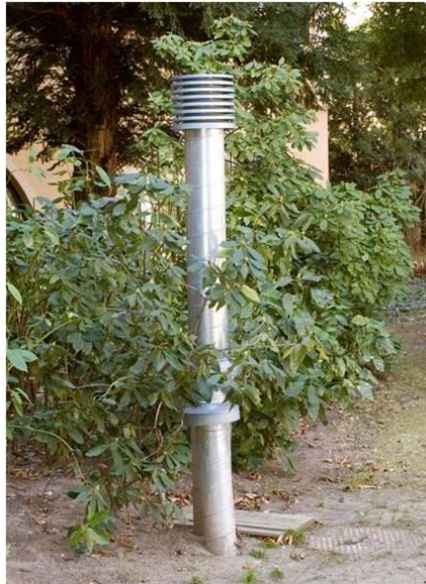
Figure 67: **Ansitz Kofler**. Inlet for the ventilation system pre-heating the air via the ground.

In **Ansitz Kofler** the air for the ventilation system is pre-heated in winter and pre-cooled in summer with a ground-to-air “heat exchanger”. The pipes are placed at 1.5 to 2.0 m depth in the soil around the buildings, with a gradient of 2% to guarantee condensation discharge and an antimicrobial layer consisting of silver particles. The air inlet has a dust and pollen filter, a further benefit to allergy sufferers. The system does not rely on a heat pump as other systems and instead the inlet-air is simply cooled/heated by travelling through pipes in the ground.

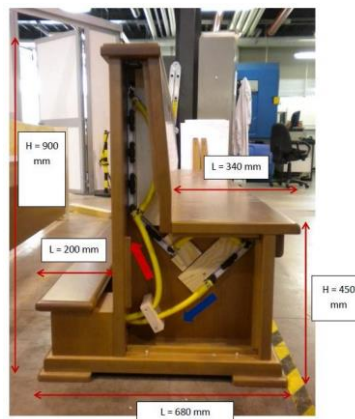
Figure 68: **Basilica di Santa Maria di Collemaggio**. Cross-section of bench with hydronic heating.

For **Basilica di Santa Maria di Collemaggio** (a church) heating is supplied directly to the benches where people sit during the service. It is a hydronic heating system coupled with ground-source heat pumps, and combines good local comfort levels and significant energy savings and low or no impact on the artworks and building structures. The radiant plates are extruded aluminium profiles, specifically adapted for the purpose and they have internal ducts in which the heat transfer fluid flows. The wooden structure of the bench is designed to fully integrate all pipes and joints. The heat pump has a nominal power of 30 kW (brine input temperature of 0°C and water output temperature at 40°C) with a seasonal coefficient of performance (SCOP) of the geothermal heat pump system equal to 4.0.

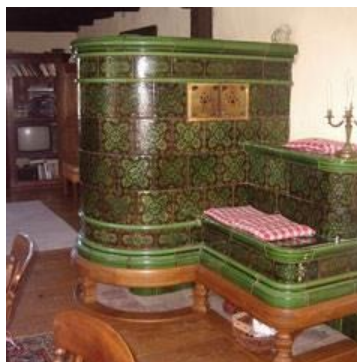
Figure 69: **Timber-framed house in Alsace**. Traditional stove as extra heating source.

For **Timber-framed house in Alsace** a 25 kW pellet boiler was installed in the technical room together with a pellet silo. It provides heating and domestic hot water through two storage tanks. A traditional stove, a so-called "Kachelofen" was also installed as additional heating source. This kind of stove was the principal heating system in Alsatian houses before the 20th century and it is supplied by logs and takes its air supply directly from the outside.

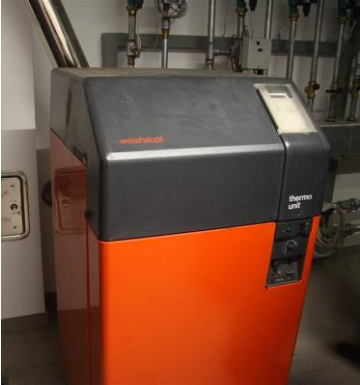
Figure 70: **Rainhof**. Biomass boiler that together with a biogas boiler produces heat and hot water.

In **Rainhof** the new heating system works as a combination of a biogas boiler and wood-chip boiler providing heat and domestic hot water. A traditional stove is kept in the "Stube" (living room) although it is not heated with firewood anymore; instead, it is connected to the central boiler. Almost all rooms are heated through a floor

heating system. However, in some rooms old wood floorboards were restored and here therefore radiators are used instead. The biomass boiler uses wood chip produced directly from the farm woodland and stored in the silo next to the building. The gas boiler runs with the biogas produced from the manure of the cattle reared in the farm in a biogas plant built between the stable and residential building. The energy produced from biogas and wood chips cover the energy need of the **Rainhof**, a nearby house (included holiday apartments) and the stable.

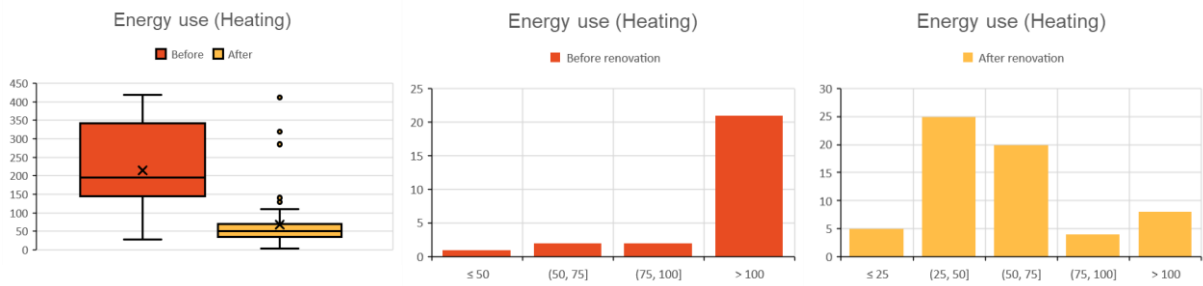
Figure 72. Energy use for space heating in kWh/m²y before and after retrofit ($N_{before}=26$, $N_{after}=62$)

A summary of the energy use (for space heating) of the entire sample before and after the retrofits is presented in Figure 72. The results in the first plot on the left show graphically a significant reduction (around 70%) in the demand of energy for space heating, but also a much more concentrated distribution of results. When looking at the histograms of both subsamples (before -middle- and after -right-), further detailed information can be accessed. After the renovation, most of the cases documented have an energy demand between 25 and 75 kWh/m²y.

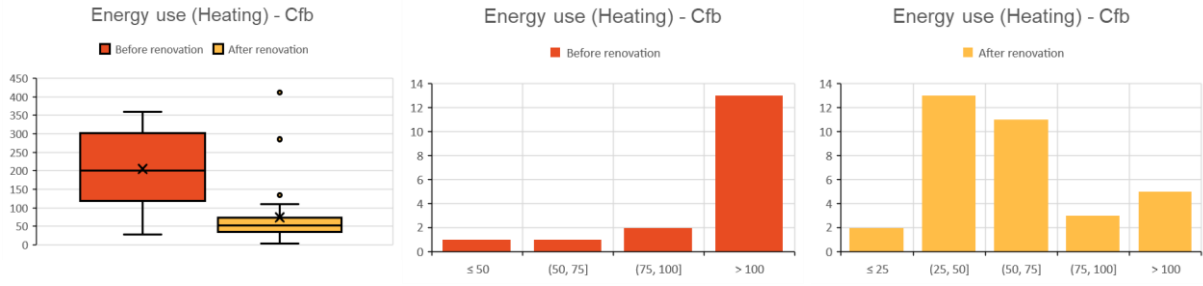
Figure 73. Energy use for space heating in kWh/m².y before and after retrofit in climatic zone Cfb

These results are heavily influenced by the climatic conditions, with colder climates having a higher energy demand. In order to minimise this uncertainty a detailed analysis of a subsample with homogeneous climatic conditions was performed. Of the documented cases, the climate Cfb⁶ (Temperate oceanic climate; coldest month averaging above 0 °C, all months with average temperatures below 22 °C, and at least four months averaging above 10 °C) is by far the most representative (38 out of 69). The plots in Figure 73 show the same analysis for the subsample. The distribution of results of the case studies in climate Cfb is almost identical to that of the entire sample, with a great majority of cases above 100kWh/m²y before the renovation and between 25 and 75 kWh/m²y afterwards.

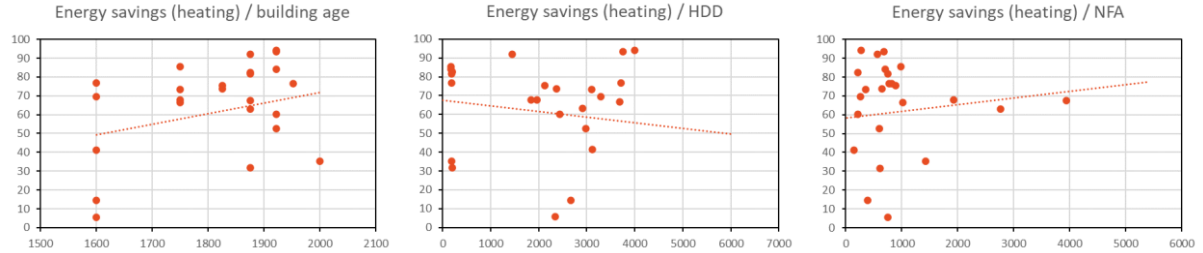
The plots in Figure 74 show the energy savings achieved (in %) when looking at the space heating demand. In all three plots, the energy savings are plotted as a function of a second variable (building construction period, Heating Degree Days, and Net Floor Area respectively). In general, the correlation between the energy savings and all three variables studied is fairly weak. Surprisingly, there is a positive relationship between savings and building constructions period suggesting that the more modern buildings profit more (in relative terms) of the energy retrofits. When it comes to HDD and NFA the relationship is slightly negative and positive respectively, suggesting that the colder the climate and the bigger the building, the higher is the energy saving achieved in relation to the energy demand before the intervention.

Figure 74. Energy savings (in %) in terms of space heating demand ($N=25$) as a function of building age ($R^2=0.05$), Heating Degree Days ($R^2=0.02$), and Net Floor Area ($R^2=0.01$).

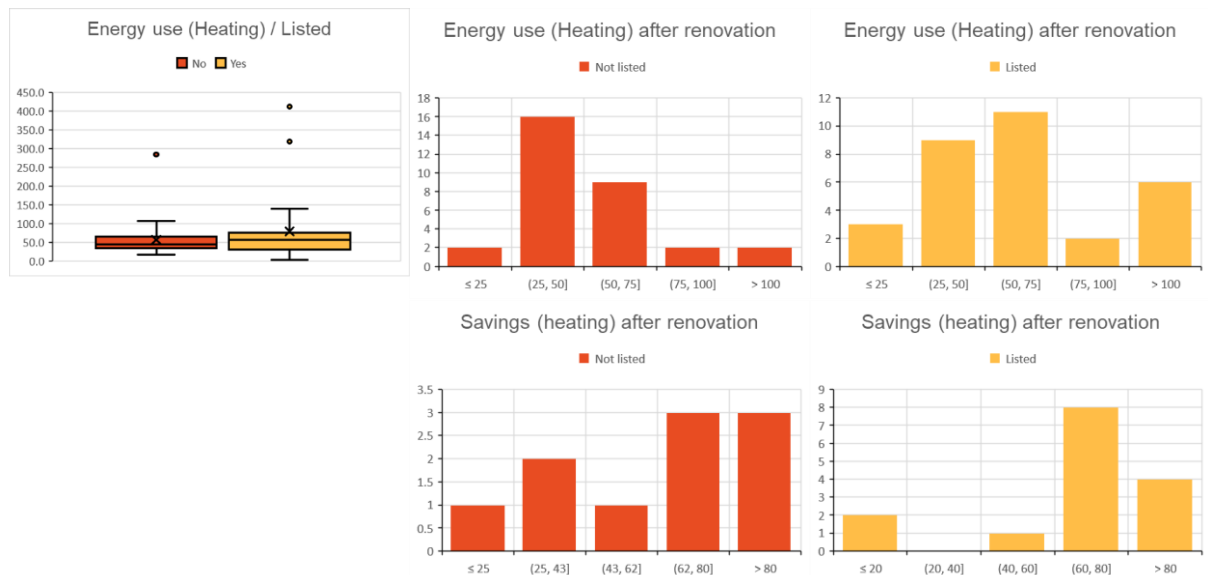
To understand the limitations imposed by the legal status of the building (in terms of heritage protection), the analysis also looked into the different performance of listed and not listed buildings. Figure 76 shows the energy use and savings for both subsets. The energy use after the retrofit is slightly higher in listed buildings (top left). The histograms (top centre and top right) show slightly different curves with most cases in not listed buildings with an energy use between 25 and 50 kWh/m²y and 50 to 75 kWh/m²y in the case of listed buildings. The energy savings histograms on the other hand, show very different profiles. Whereas in the case of not listed building the cases are spread across the different ranges, in the case of listed buildings, most of the cases are concentrated in the range between 60 and 80% energy reduction.

Figure 76. Energy use for space heating in kWh/m²y and energy savings in % for listed and not listed buildings

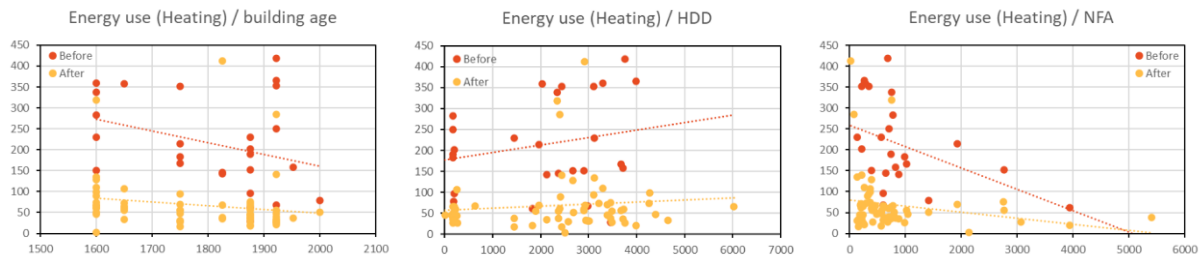
To understand how the relationship between energy consumption and other parameters of the building or site (building construction period, Heating Degree Days, and Net Floor Area), the energy use in kWh/m²y is again plotted as a function of these three parameters in Figure 77. It is important to notice how in all three plots a similar trend can be observed. The dependency of all three variables decreases noticeably after the retrofit. That is, before the energy intervention the energy demand for space heating (per m²) is inversely proportional to the building age and net floor area while at the same time the correlation between energy use and HDD is positive. After the retrofit, the

sign is maintained (negative for building age and area, and positive for HDD) but the dependency is much weaker and the variability between cases significantly lower.

Figure 77. Energy use (in kWh/m²y) before and after retrofit as a function of building's age ($R^2_{before}=0.11$, $R^2_{after}=0.03$), HDD ($R^2_{before}=0.05$, $R^2_{after}=0.01$), and NFA ($R^2_{before}=0.16$, $R^2_{after}=0.04$) (left to right)
