Case Studies Assessment Report

SHC Task 59 | EBC Annex 76 | Report D.A2

IEA SHC Task 59 | EBC Annex 76: Deep renovation of historic buildings towards lowest possible energy demand and CO₂ emission (NZEB)

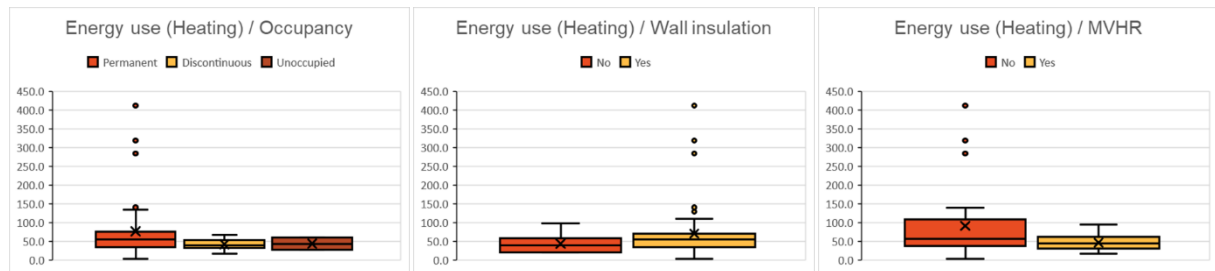
In Figure 78, the effect of different parameters of the intervention on the energy use after the retrofit is studied in more detail. The plots below show (from left to right) the effect of the type of occupancy, insulation of the external wall, and use of mechanical ventilation with heat recovery (MVHR) on the final energy use for space heating. In general, no great differences can be observed when looking at the effect of a single variable with the exception perhaps of MVHR. Buildings without heat recovery (and that also includes cases relying exclusively on natural ventilation) present a much higher variability and overall higher energy use than those with MVHR. Surprisingly, when looking at the effect of wall insulation, the cases with no intervention present better results. However, it is worth noticing that only 6 cases with no intervention in the external walls are included in the sample and thus the significance of the results might be limited.

Figure 78. Energy use (in kWh/m²y) after retrofit according to different parameters of the intervention

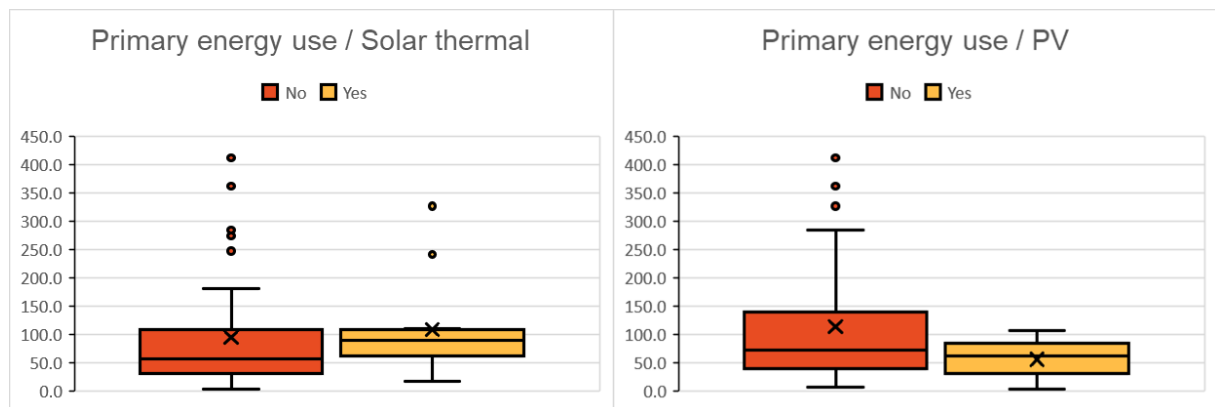
Lastly, the effect of renewable energy systems is presented in Figure 79. In this case, and to take into consideration the contribution to the total energy performance of the building, the primary energy use of the case studies after the retrofit (in kWh/m²y) is studied in cases with and without Solar thermal (left) and PV systems (right). The positive effect of solar energy is even more evident in the case of photovoltaic systems, where the total primary energy use is reduced from 113.6 to 56.1 kWh/m²y.

Figure 79. Total primary energy use (in kWh/m²y) in cases with and without Solar thermal and PV systems

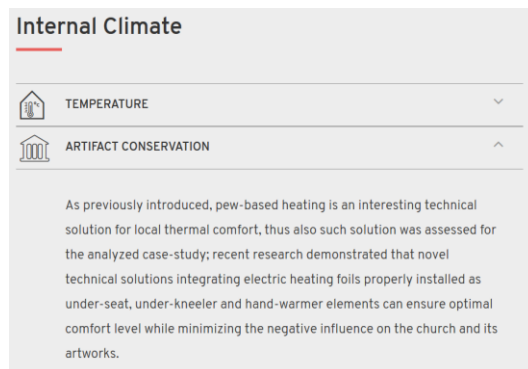
Occupants’ opinion about the performance of the building in regard to artefact conservation was only documented in ten of the 69 cases. In line with acoustic comfort, only 15% of the cases reported information considering the impact of the renovation on the artefact conservation. Arguably, this can be due to the fact that most of the documented buildings are residential and do not have any historically significant artefacts that need especial attention.

Figure 84. An example of the “Artefact conservation” answers collected from the Basilica di Santa Maria di Collemaggio

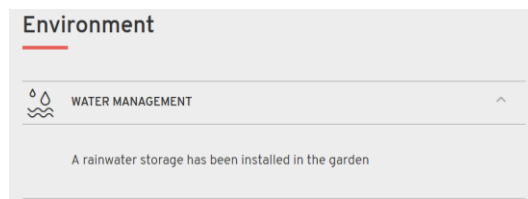
Considerations about the water management of the building after the intervention were included in just eight cases (11.6% of the projects) and the information included in these cases is usually rather generic. An example of this is shown in Figure 72.

Figure 86. An example of the “Water management” answers collected from the Maison Rubens case study
